## Attachment 3

# Project Summary/History of Chevron Guadalupe Restoration Project

This document provides a summary of the Guadalupe Restoration Project, including background information on the project, clean up and restoration work that has been completed to date, and what work is still outstanding at the site.

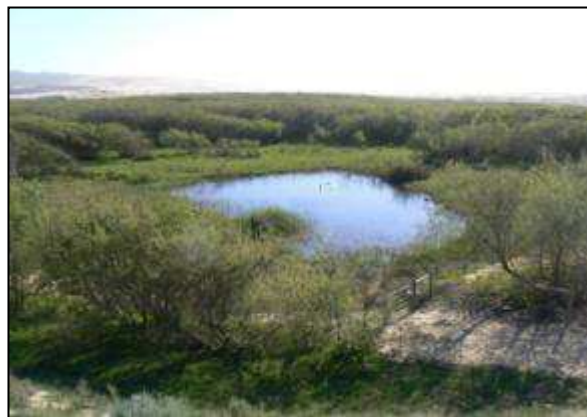
**Created Wetland at D14**

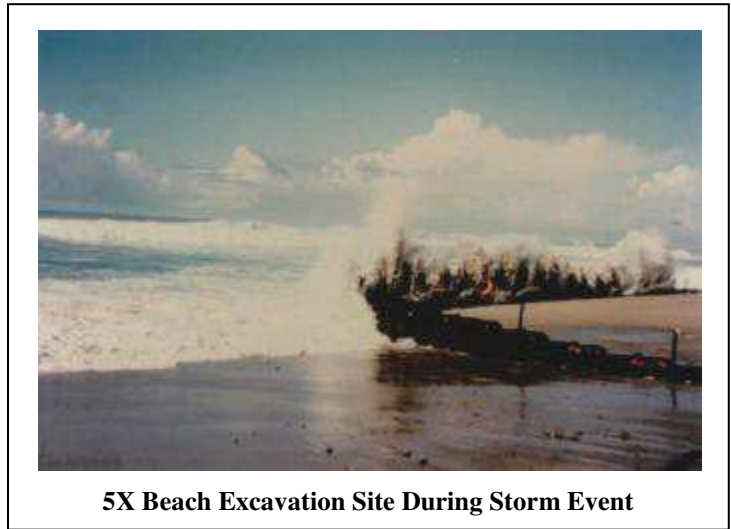
In February 1994 the United States Coast Guard issued a directive to prevent any further marine releases of diluent because it represented an imminent threat to the marine environment. In 1994, a large excavation project called 5X began at the beach to attempt to stop the marine releases of diluent. This excavation was overseen by a number of Federal, State and local agencies and was done under emergency permits.

**5X Beach Excavation Site During Storm Event**

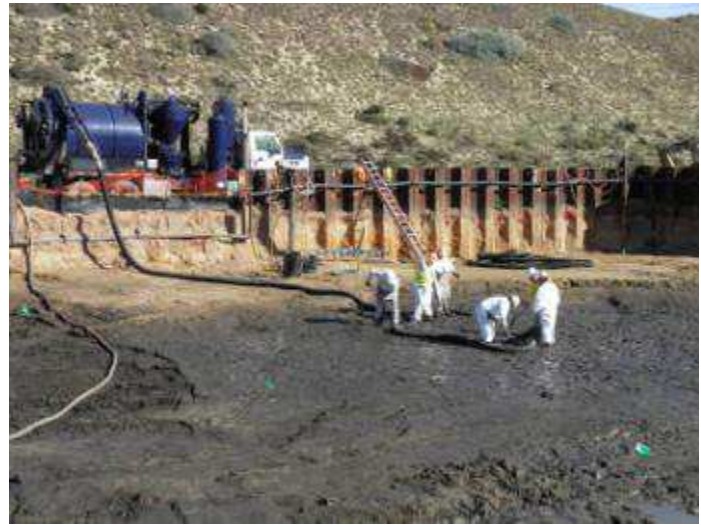
**Excavation Work at M12**

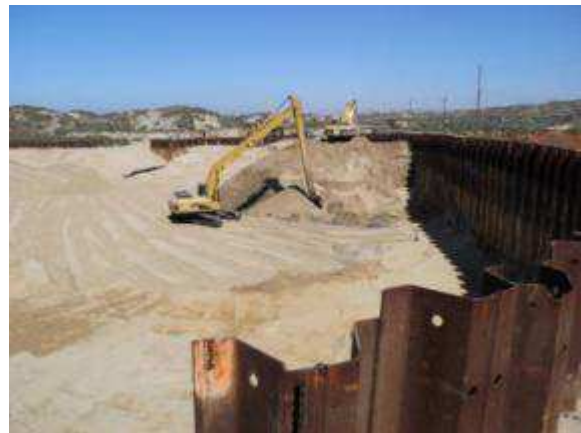
**Excavation Work at B5A**

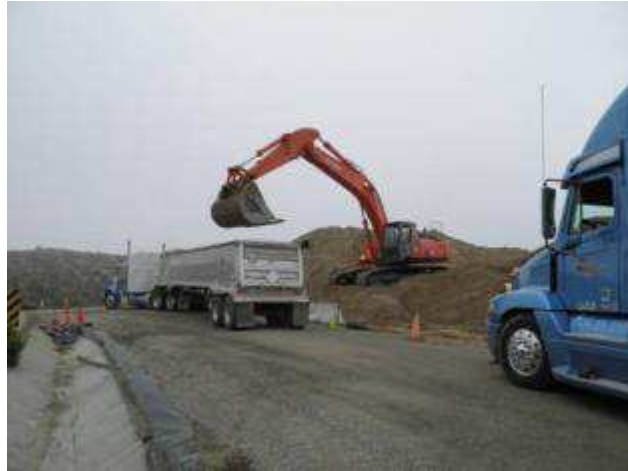
**Loading Truck with Contaminated Soil for Transport to the Santa Maria Landfill**

- A total of about 1,055,000 cubic yards of contaminated soil has been hauled to the Santa Maria Landfill for use as cover to assist in closure of the landfill. The California Department of Toxic Substance Control (DTSC) has determined that the material from the Guadalupe site is suitable for use as cover material at the Santa Maria Landfill.
- About 150 miles of pipeline have been removed from the site.
- Over 20 acres of wetlands have been created.

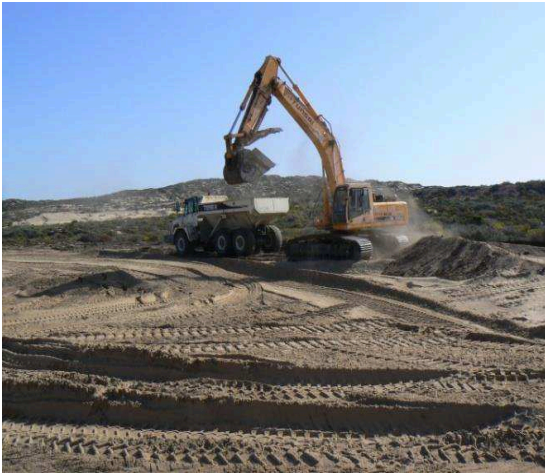
**Vegetation Removal**

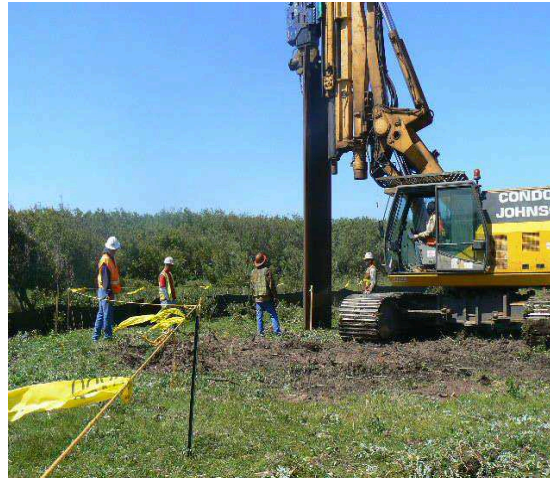
**Sheetpile Installation**

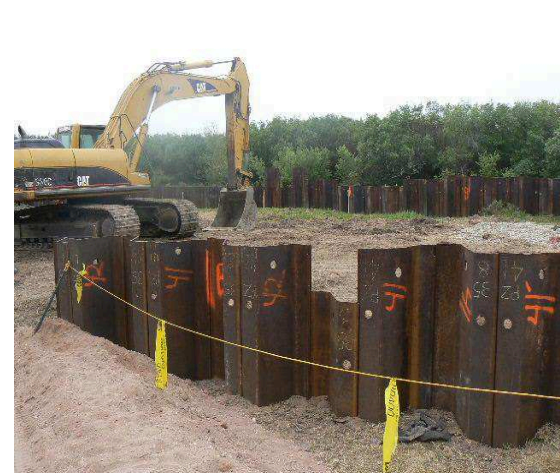
**Excavation**

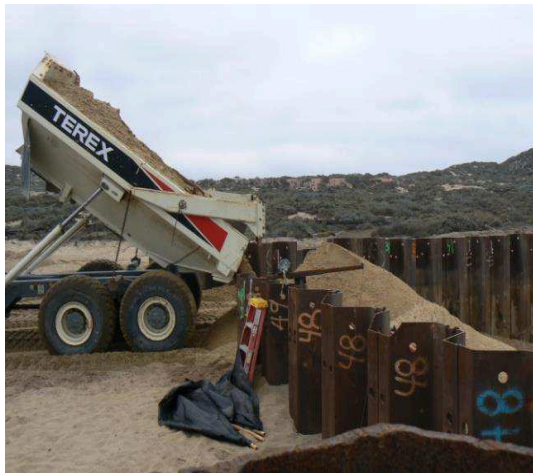
**Backfill**

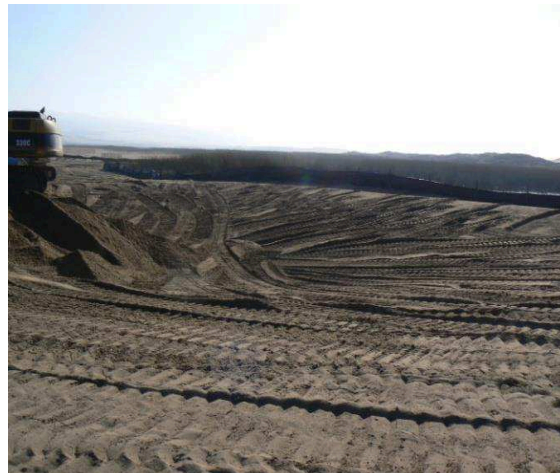
**Recontouring Final Grade**

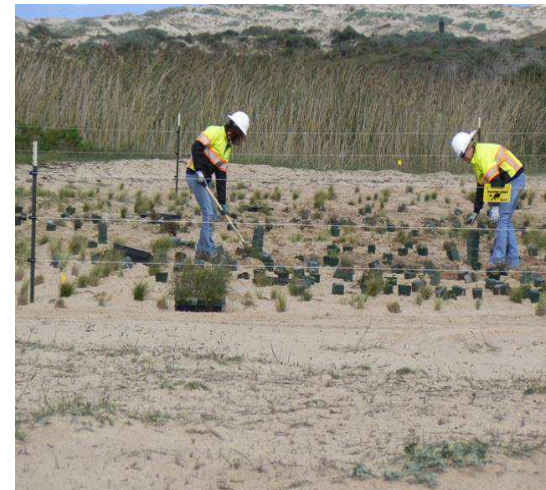
**Fencing and Replanting**

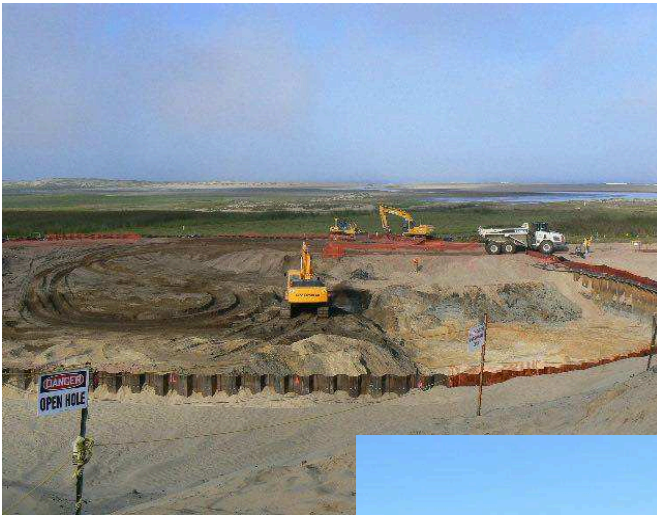
**B12 Wetland Excavation  
December 2007**

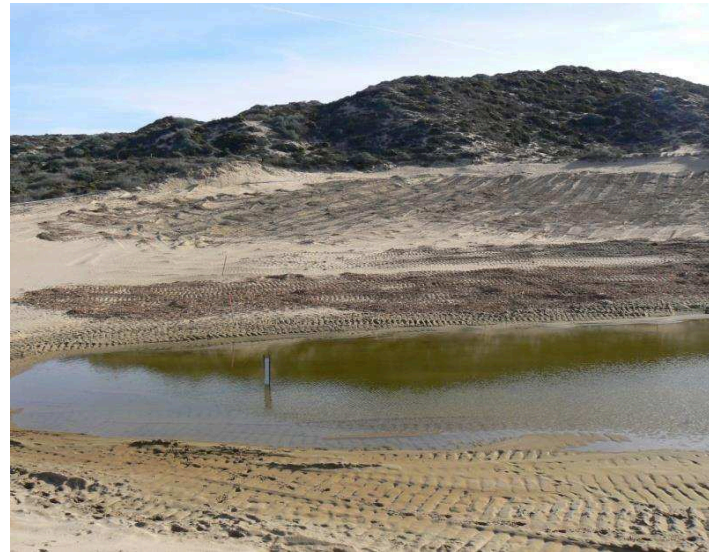
**B12 Wetland Final Grade January 2008**

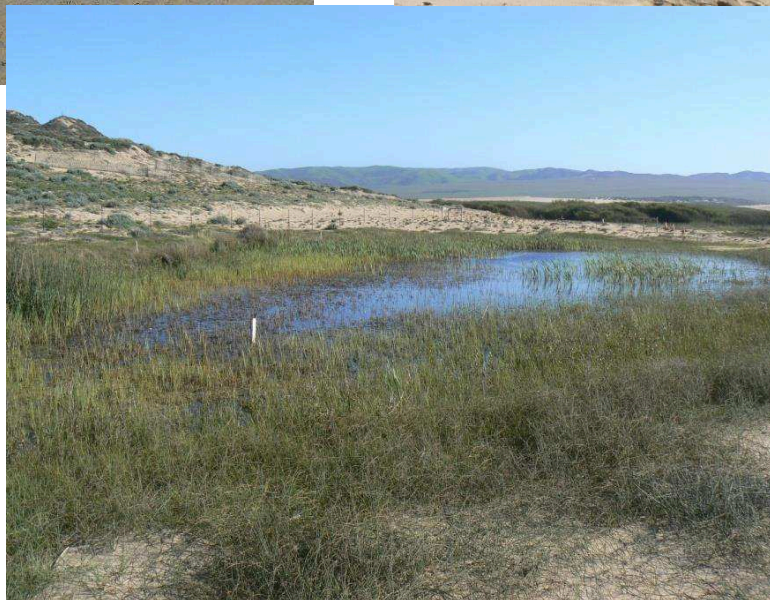
**B12 Wetland Created  
February 2010**

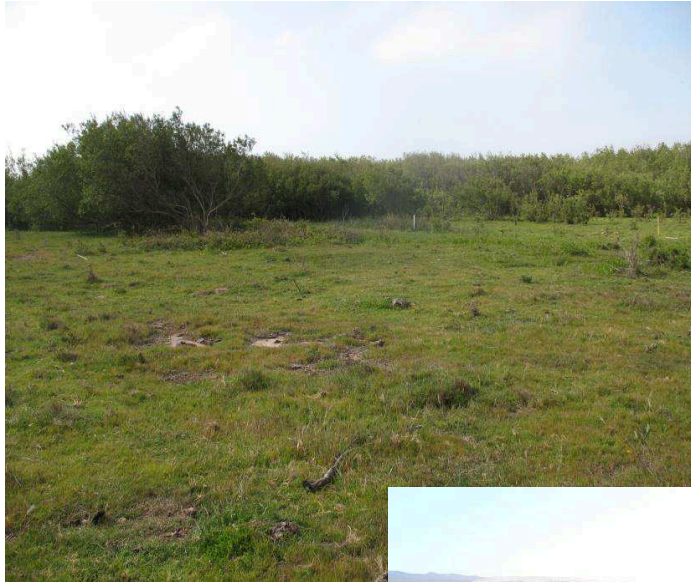
**D14 Pad Site: pre-excitation, June 2007**

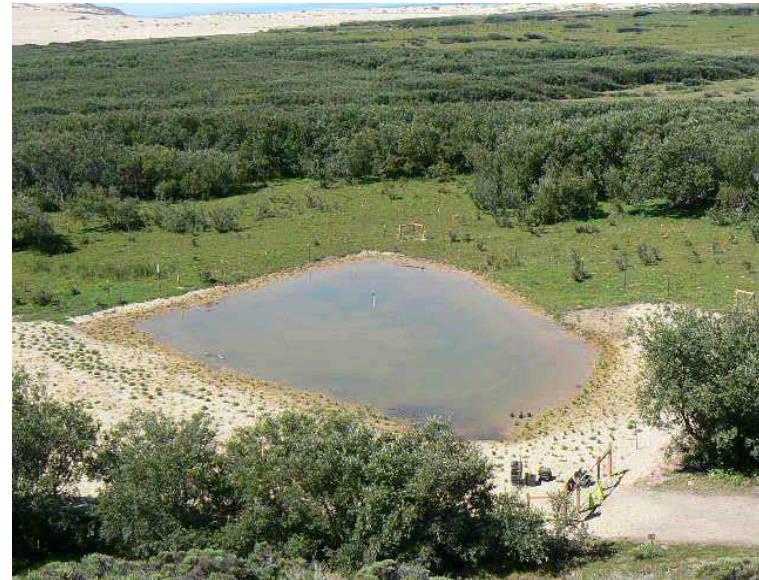
**D14 Site: post-excitation  
Final Grade, July 2007**

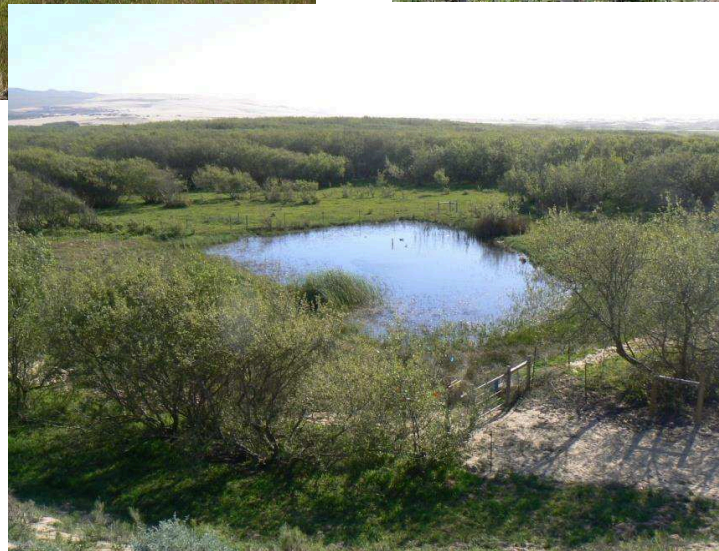
**D14 Restoration Site: post  
excavation, February 2010**

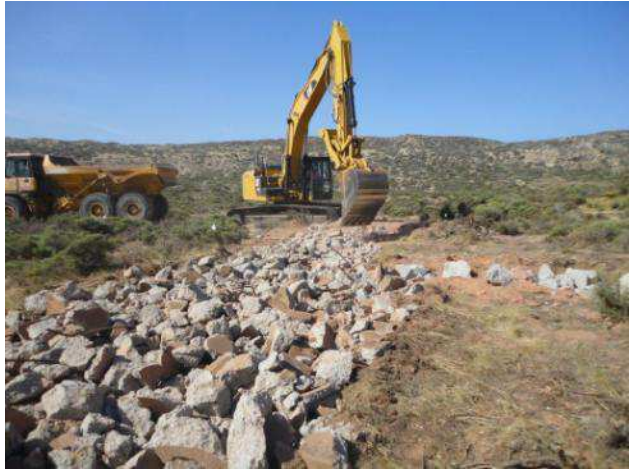
**Breaking up concrete slab, which will be excavated and site will be restored**

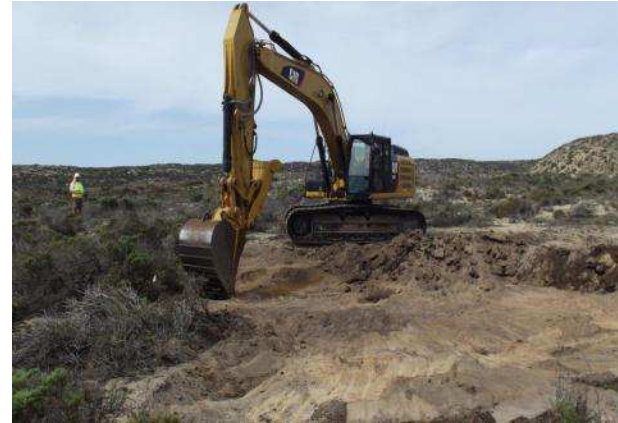
**Sump removal during treatment of Pad**

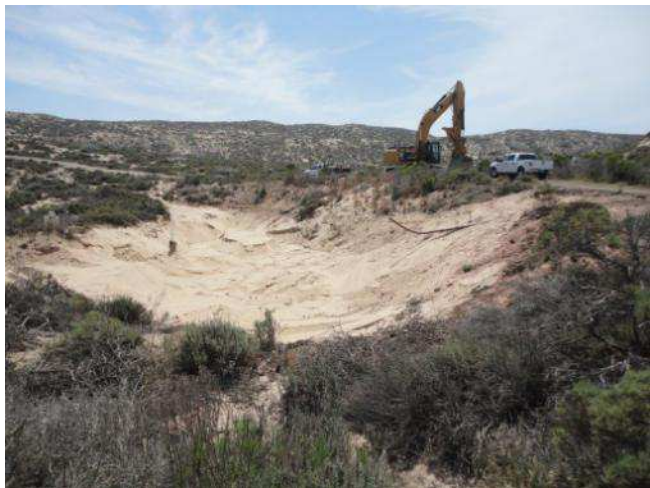
**Post Excavation: sump removal during treatment of Pad**

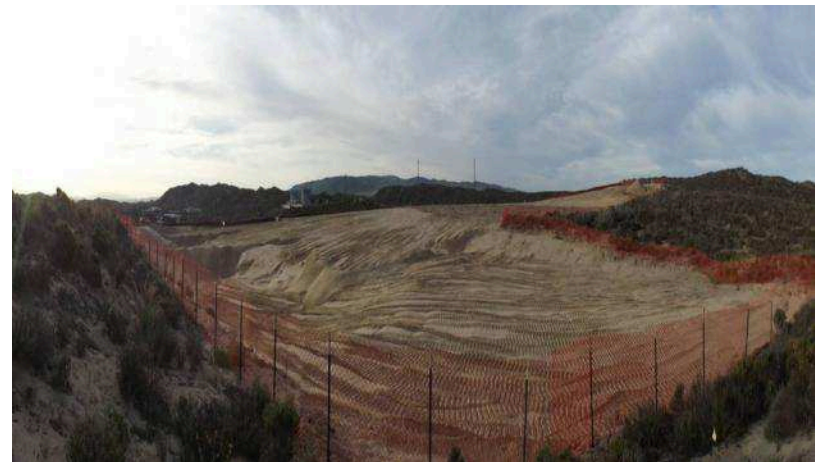
**ZH5 Excavation Area (before): immediately after excavation.**

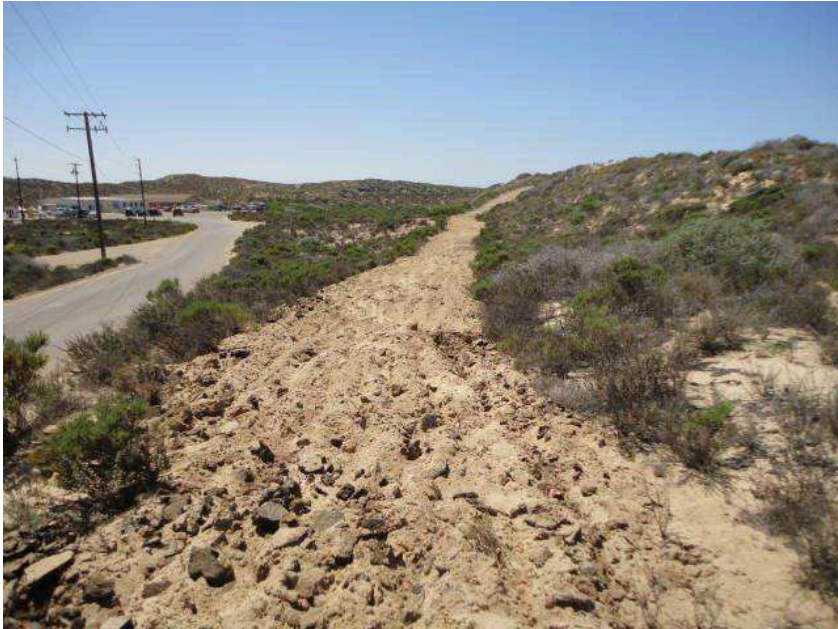
**P3 Road near Main Office (same road as previous photo): after treatment and sand placement**

various methods of pad removal or treatment in place. Treatment included various forms of ripping of the asphalt road or red-rock pad site, leaving that material in place, and covering the ripped road or pad with clean sand for future habitat restoration. The results of this test program were reviewed and approved by the County staff and agency reviewers in 2014, and are currently being put into action under the 2015 PROS Program Work Plan. It is expected that the treatment and removal of roads, pads and oil spray areas will take two to four years to complete.

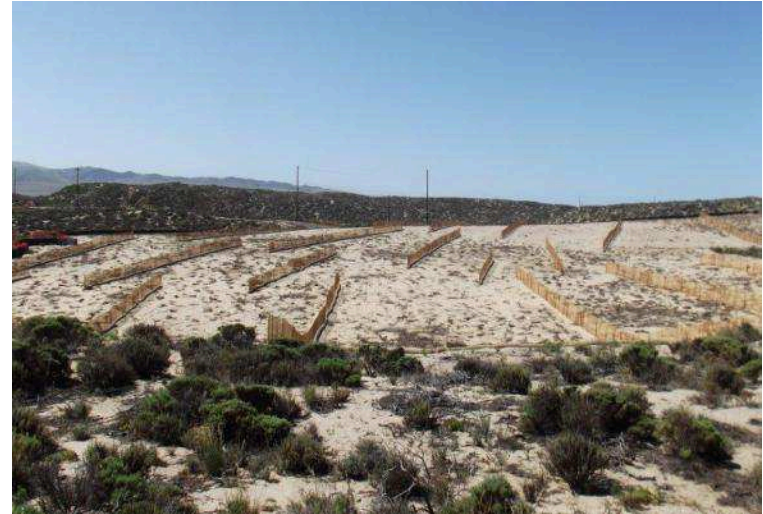
**ZH5 Excavation Area (after): after excavation, backfill, grading, and placement of vegetation and installation of BMPs**

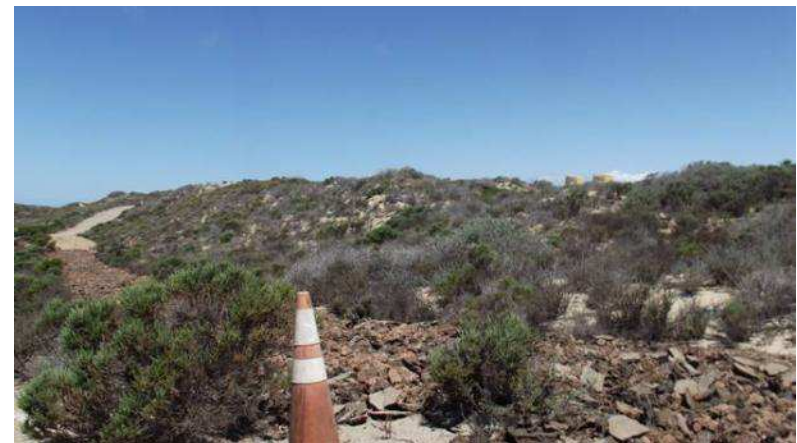
**P3 Road near Main Office: after treated (asphalt and red-rock base material broken up)**
